WATER TREATMENT NEWS

Don't Let "Cancer" Destroy Your Cooling Tower System

Volume 36
Summer 2009

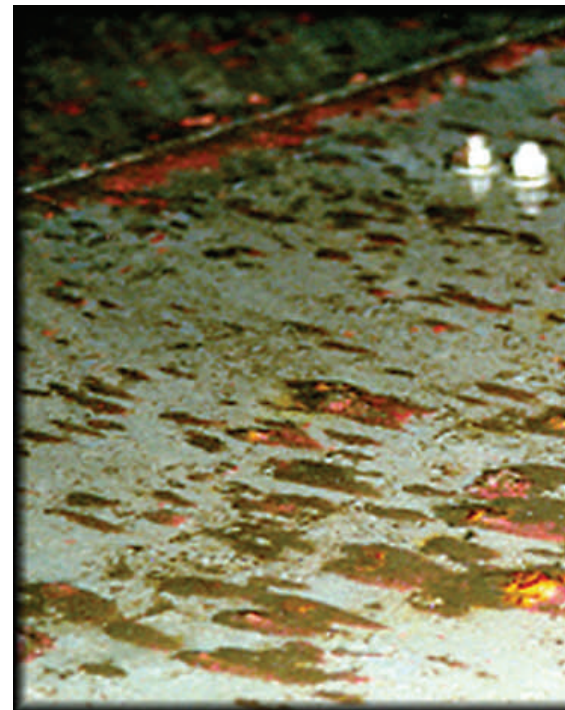
Tower basin with typical reddish to yellow growth.

The presence of SRB in a cooling tower system is usually characterized by the appearance of reddish or yellowish colored nodules on metal surfaces, frequently in the tower basin. Breaking the nodule reveals a black, slimy liquid which, when cleaned away, shows evidence of a shiny silver pit. These are certain indicators of active SRB growth, which can be verified using the Hach BART or Sani-Check SRB test.

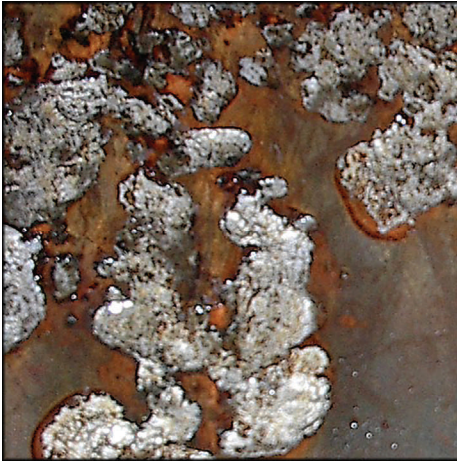
When nodules are removed, deep pits are revealed. If left unchecked, SRB-caused corrosion can penetrate a tower basin in months or even weeks

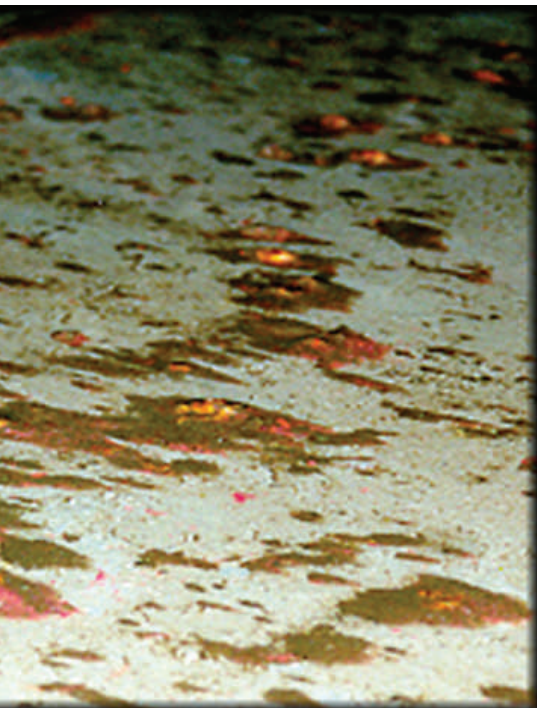
reddish SRB nodules. Green material is algae
